AA-926 Cecil-Bond House Millersville Private

AA-926 Cecil-Bond House

Maryland Historical Trust State Historic Sites Inventory Form

Survey No. AA-926

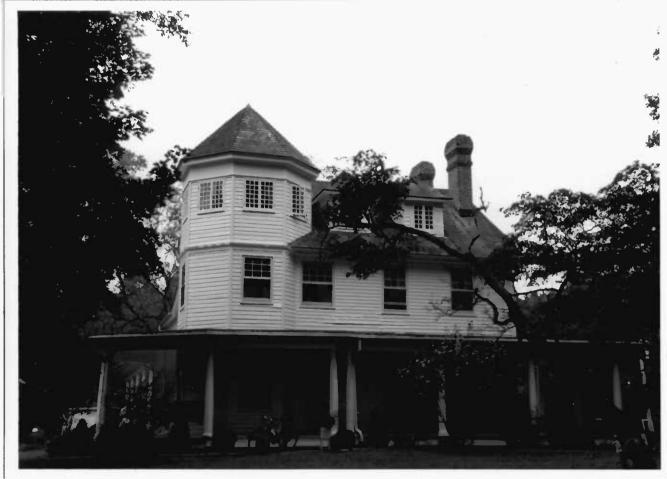
AA-9260 Cecil-Bond House Anne Arundel Co., Maryland Sherri M. Marsh, Photographer Sept. 1996 North facade Negative at Maryland SHPO Photo 1 of 10

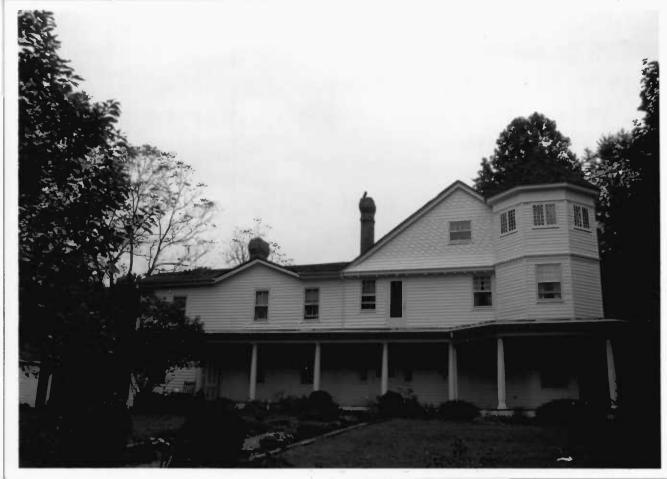
AA- 926 Cecil-Bond House Anne Arundel Co., Maryland Sherri M. Marsh photographer Sept. 1996 east Facade Negative at Maryland SHPO Photo 2 of 10

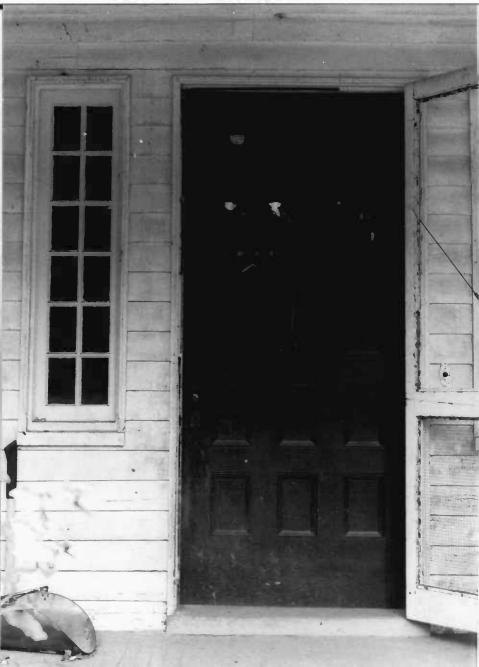
AA- 926 Cecil-BOND House Anne Arundel CO, MARYland Photo By Donna Ware, 1991 NEG. AT MARYland SHPO FRONT DOOR - prior to restoration Photo 3 of 10

Window types vary. The Queen Anne section's tower and dormers feature respectively pairs of eighteen- and ten-light casement windows, while nine-over-one double-hung sash windows are present in first and second floor openings. Two-over-two windows typify the rear section. The house's imposing front door contains beveled glazing in the upper third, with three, three-panel rows in the lower section. A similar door serves as an east-side entrance.

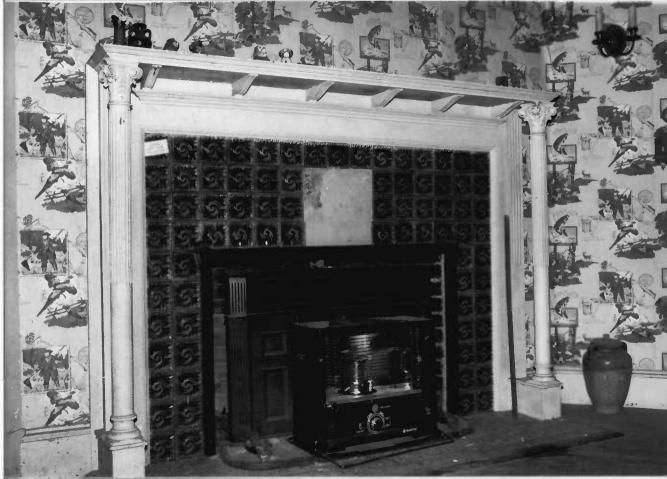
AA-920 Cecil-Bond House Anne ARUNDEL CO., MARY and Photo By Donna Ware, 1991 NEG. AT MARY land SHPD FIREPlace Detail - Prior to restoration Ph 20 5 05 10

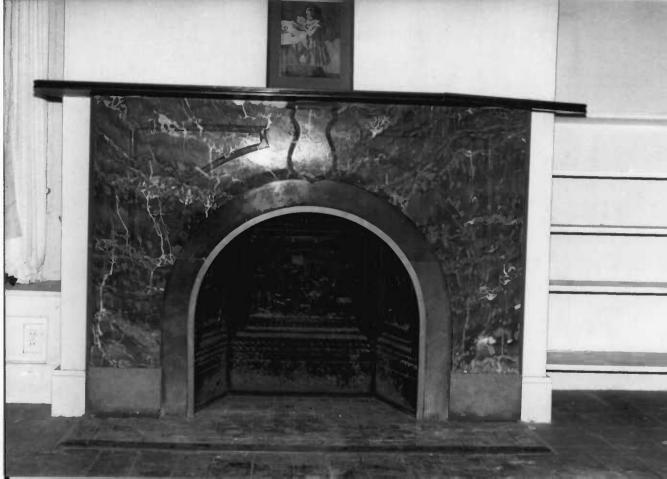
AA-926 Cecil-Bond House ANNE ARUNDEL CO, MARYLAND Photo By Donna Ware, 1991 NEG, at MARYLAND SHPO FIRE Place PETAII-prior to restoration Photo 6 of 10

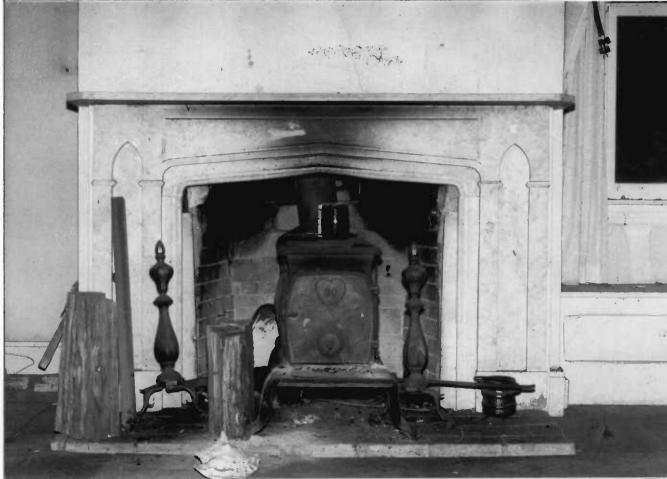
AA - 926 Cecil-Bond House ANNE ARUNDEL CO, MARYLAND Photo By Donna Ware, 1991 NEG. AT MARYLAND SHPO FIREPLACE DETAIL - Prior to restocation Photo 7 of 10

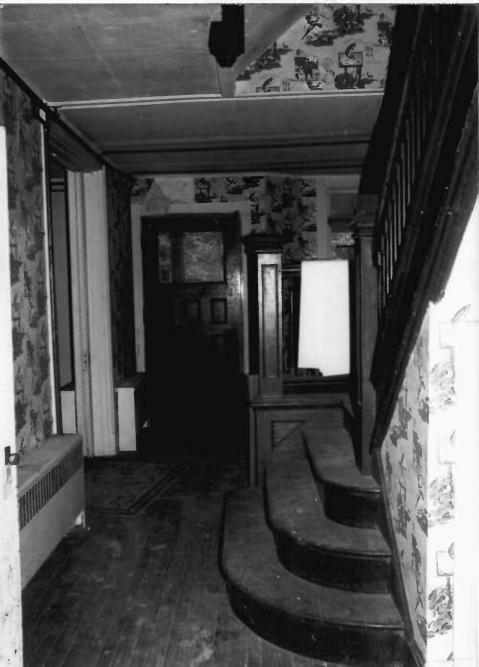
AA - 926 Cecil-Bond House Anne Arundel Co., MARYland Photo By Donna Ware, 199/ Neg. at Maryland SHPO Entry Halls Camora facing front entrance. Proto 8 of 10

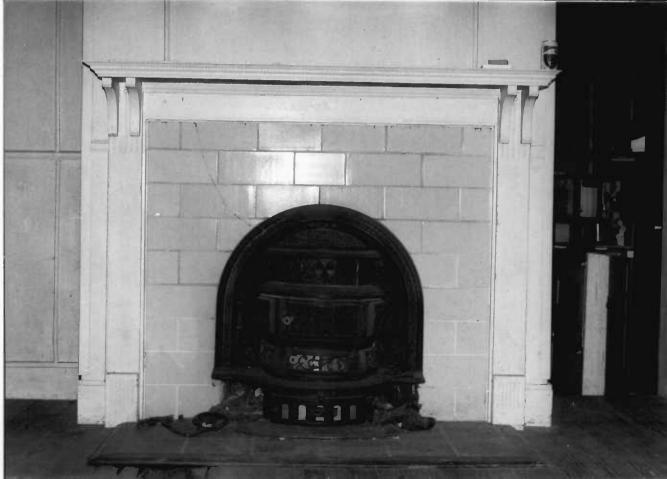
AA - 926 Cecil-Bond House Anne Arundel Co, MARYland Photo By Donna Ware, 1991 NEG. AT MARY and SHPO Fire Place Detail - prior to restoration Photo 9 of 10

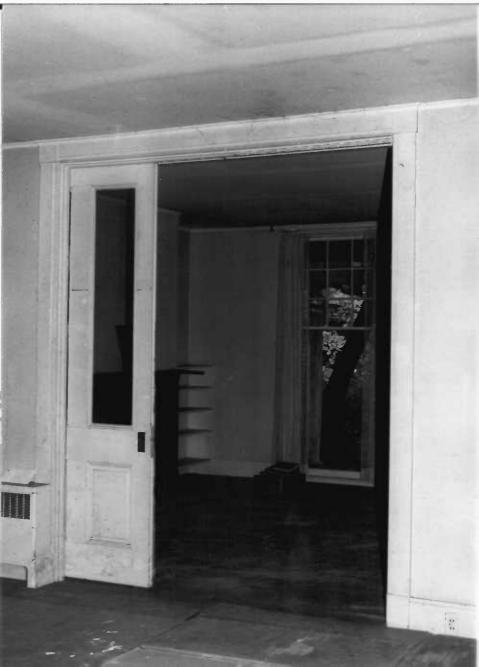
AA-920 Cecil-Bond House ANNE ARUNDEL CO., MARYLAND Photo By Donna Ware, 1991 NEG. AT MARYCAND SHPO Pocket Doors seperating forlors -Proto 10 0f 10
